Manhole Inspection Summary

Manhole # S37GG1014MH

Insp Date: **1/9/07 11:16 AM**

Location Address: **3904 GREENMOUNT AVE**

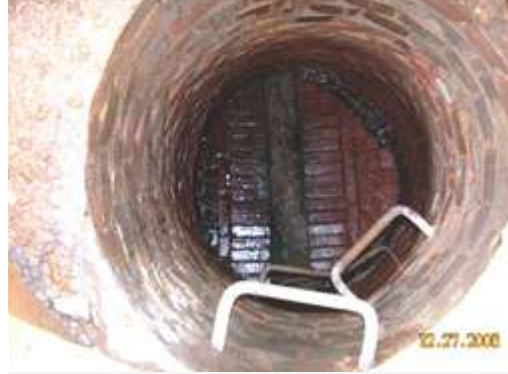
Top View

Corroded steps. Evidence of surcharge - Bench debris.

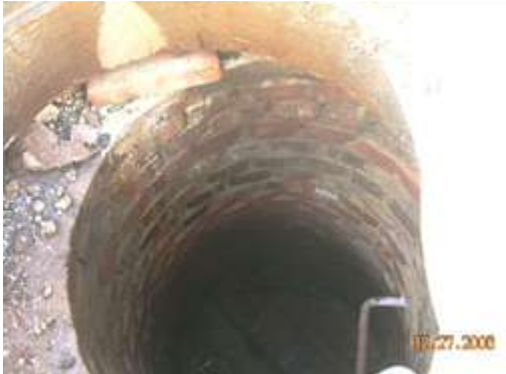
Defect

☒ **Leaks**

Condition: ☐ Sound ☐ Cracked ☐ Root Intrusion ☒ **Loose Brick** ☒ **Deteriorated**

Infiltration: ☐ None ☒ **Joint** ☐ Cracks ☐ Mortar ☐ Roots ☒ **Wall**

Frame leaks. Adjustment deterioration, loose bricks and infiltration. Barrel infiltration.

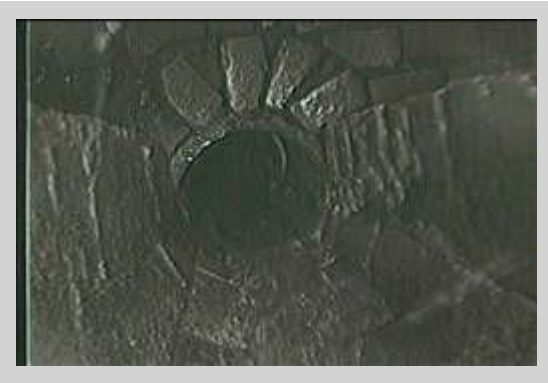
Pipe Out @ 12 O'Clock

Condition: ☐ Sound ☐ Cracked ☐ Root Intrusion ☐ Loose Brick ☒ **Deteriorated**

Infiltration: ☐ None ☐ Joint ☐ Cracks ☒ **Mortar** ☐ Roots ☒ **Wall**

Condition: ☐ Sound ☐ Cracked ☐ Root Intrusion ☒ **Deteriorated** ☐ Leaks ☐ Debris

Barrel deterioration and infiltration. Channel deterioration.
